## **Product Safety Notice**

RE: Panasonic Hospitality Display Model TH-55LRU50 & TH-55LRU50N

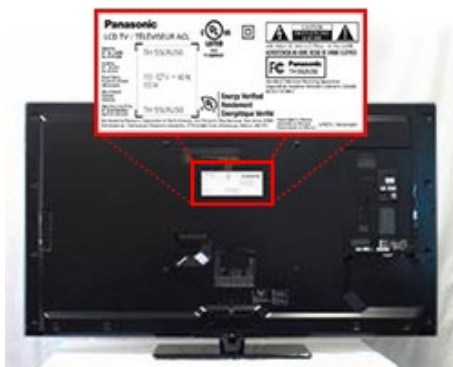
Hospitality Television Display	Distribution
TH-55LRU50	75 units sold
TH-55LRU50N	52 units sold

The model number is printed on a tag located in the center of the back of the television. The swivel stand is a glossy black color and measures 50.5 inches long by 32 inches tall by 11.1 inches deep. There is a label on the front underside of the base as well as a number etched into the metal.

A potential television tipping hazard has been identified. The weight of the television display may cause a deformation of the resin in which the pedestal mounting screws are inserted. Repeated swivelling of the pedestal may result in unsteadiness of the television due to loosened screws.

**If you have a TH-55LRU50 or TH-55LRU50N please contact Panasonic Canada to arrange for a Servicer (if necessary) to install a Reinforcement Kit (if pedestal mounted).**

1. A metal plate to distribute the load evenly and prevent deformation of the pedestal mounting area.
2. Replacement screws of increased length and locking shape to increase the frictional force of the thread.
